New York State Department of Transportation General Bridge Inspection Report

Inspection Date: April 22, 2021

BIN: 1031701

Feature Carried: 81I 81I33033050

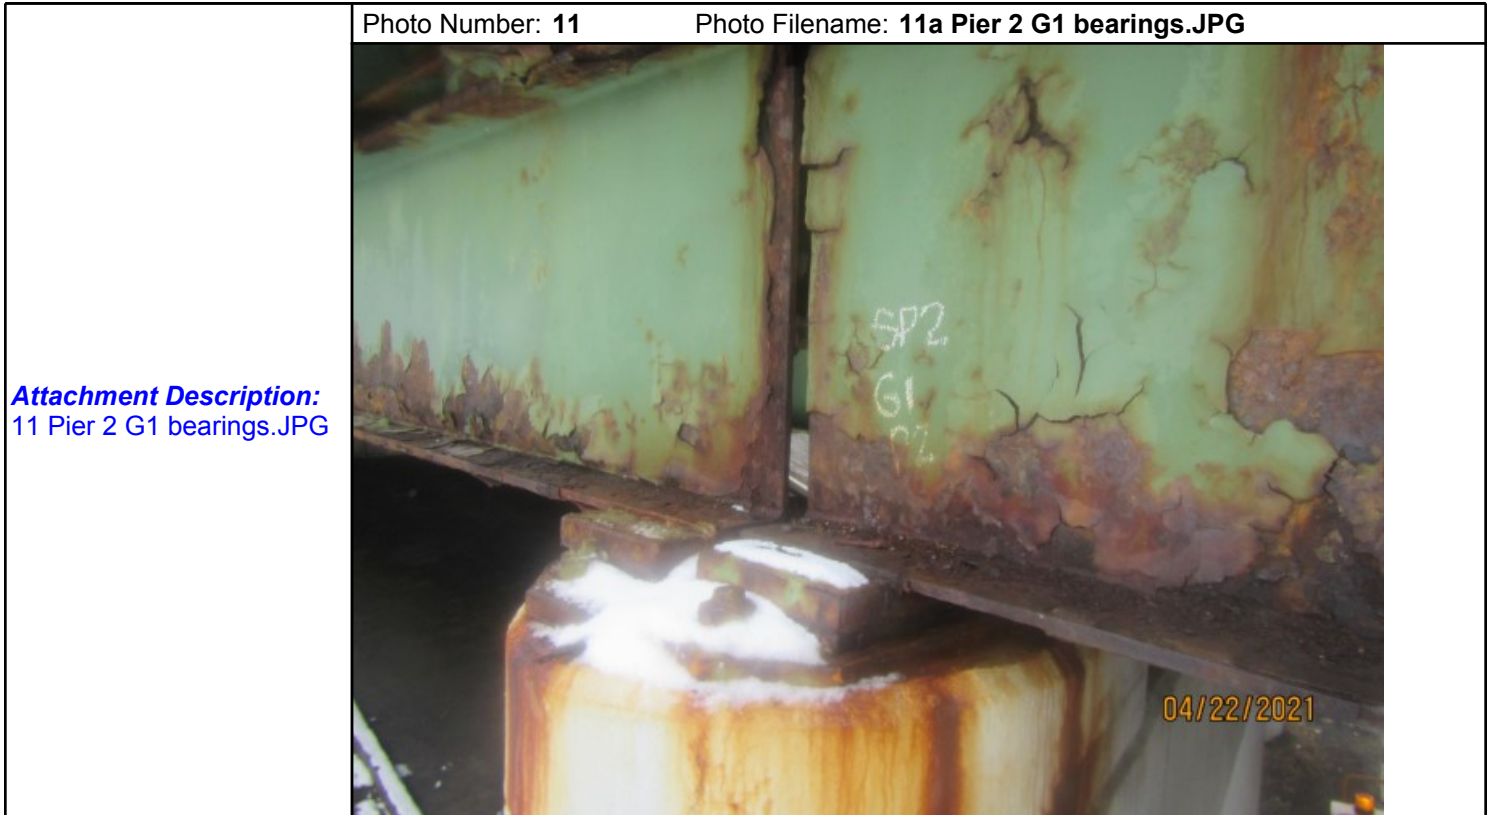
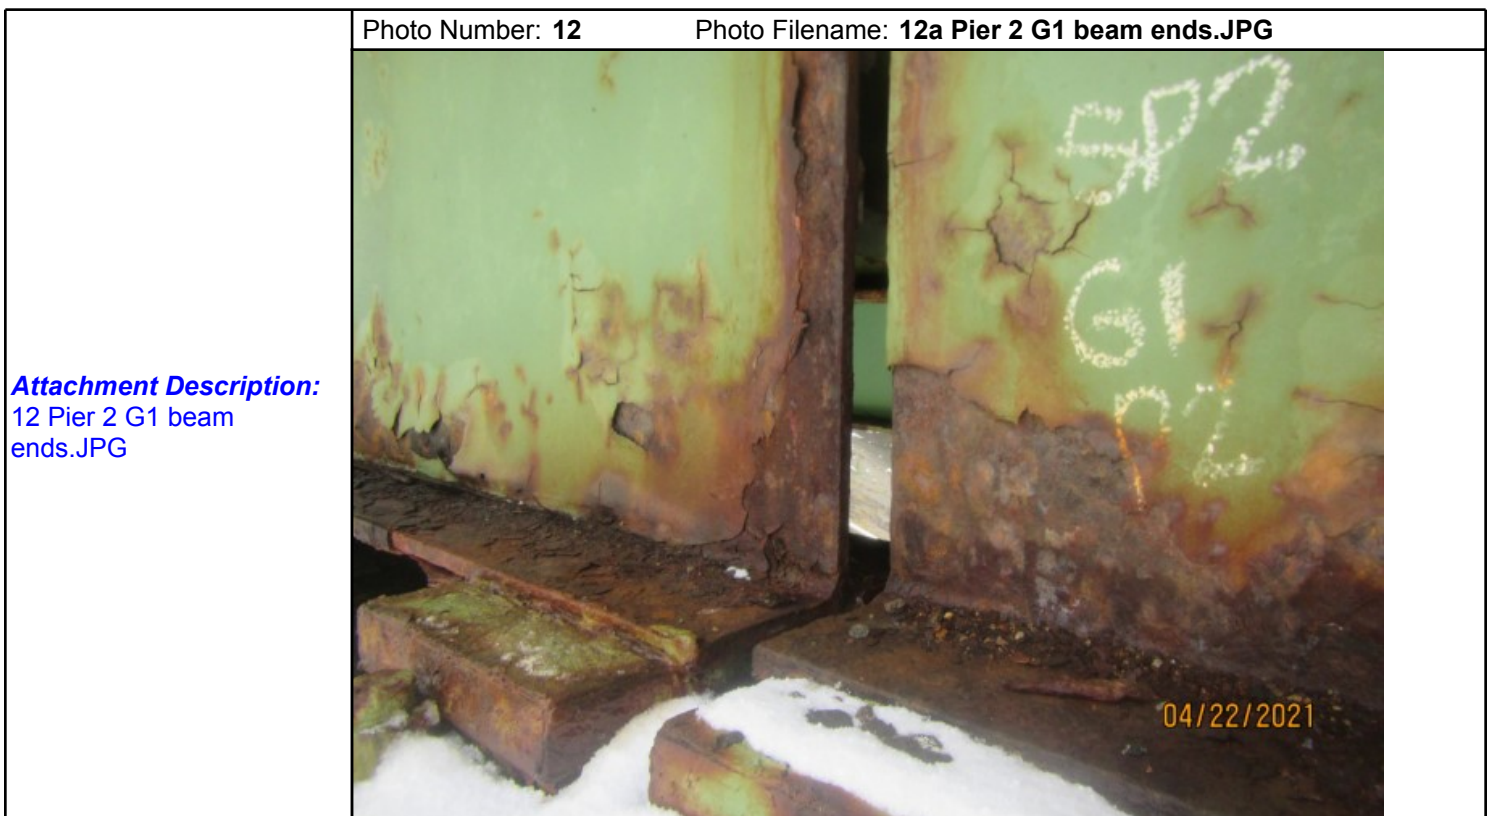
Photo Number: 13

The paint has failed on 30% of the bearing components (Pic#23) and 50% of the galvanization has failed on the bridge rail (Pic#29&36) has allowing base metal to corrode in all three spans. The G1 and G7 fascia bearings (Pic#1,11,13&38) have about 70% paint failure.

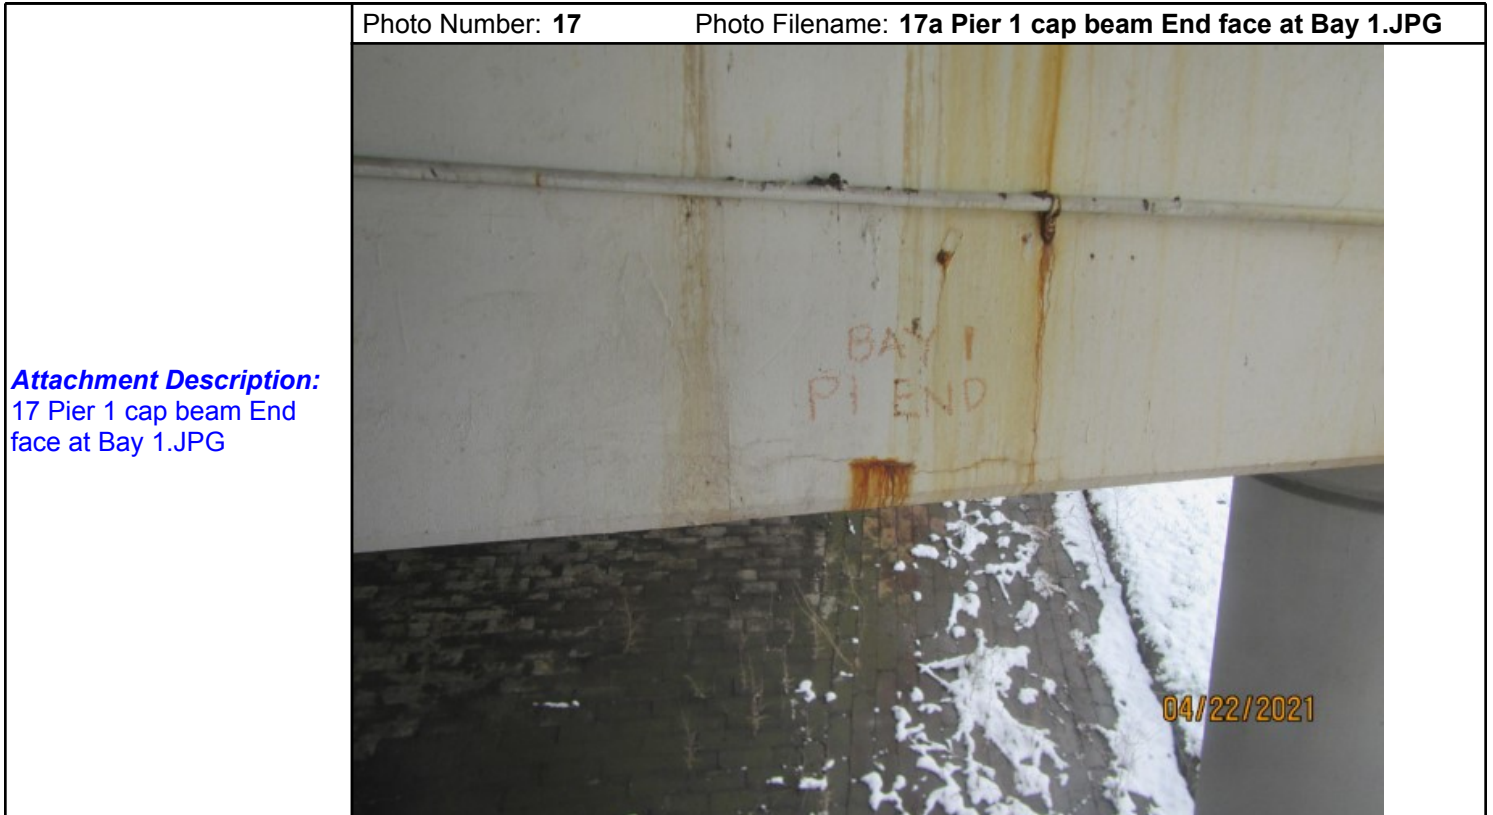
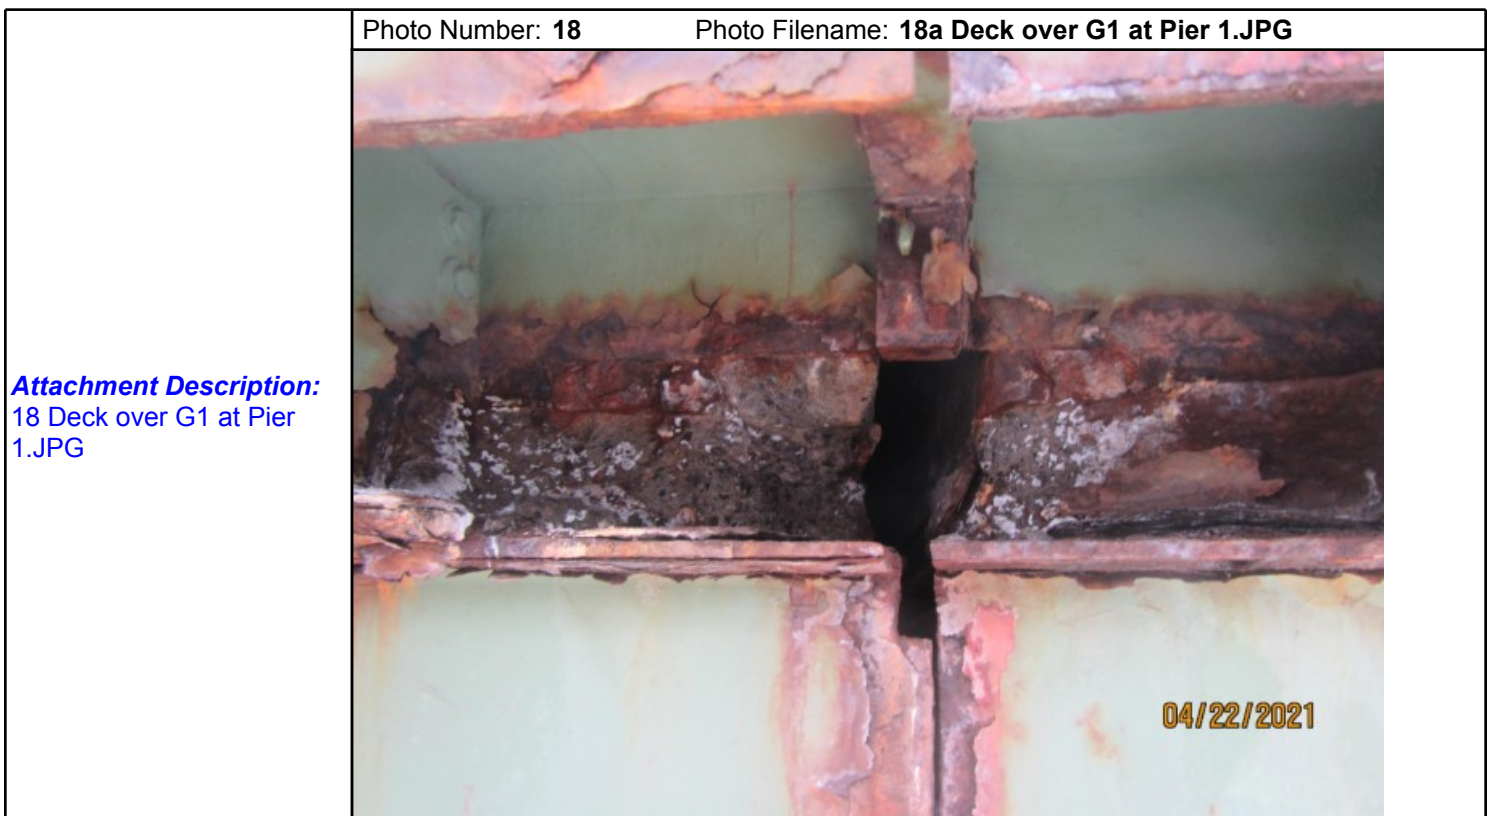
Photo Number: 19 Photo Filename: 19a Pier 1 cap beam End face at G6.JPG

Pier 1 - The cap beam in bay 1 has a 2.5' long crack on its end face and underside (Pic#17) upto 1/8" wide. Under G5 at the end face of the pier cap there is a 4' long long horizontal crack at the bottom corner upto 1/8" wide. Under G6 at the end face of the pier cap there is a 3' long horizontal crack at the bottom corner (Pic#19) upto 1/8" wide.

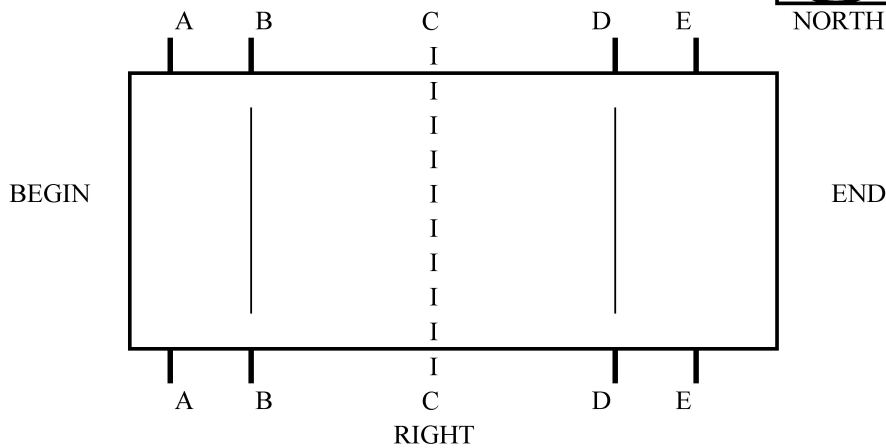
**SPAN 2
LEFT**

YEAR>	2017	2017	2019	2019	2021	2021
LOCATION	LEFT	RIGHT	LEFT	RIGHT	LEFT	RIGHT
A	17'1"	15'6"	17'2"	15'6"	17'2"	15'6"
B	17'0"	15'6"	17'0"	15'5"	17'0"	15'5"
C	16'5"	14'10"	16'5"	14'10"	16'5"	14'10"
D	16'0"	14'5"	16'2"	14'5"	16'2"	14'5"
E	16'1"	14'5"	16'2"	14'6"	16'2"	14'6"

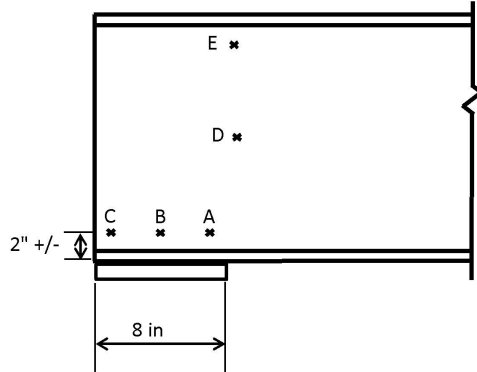
Girder End Section Loss Documentation at Span 2 Pier 2

Span 2: 12 - Reinforced Concrete Deck	TQ	CS-1	CS-2	CS-3	CS-4	CS-5
	2470	1813	617	40	0	0
	2470	1813	617	40	0	0
Condition State 3 Note Referenced Photo(s): 8 Referenced Sketch(es): None						
There's a 40sf unsound area in bay2 at End span. The condition of the deck is adequately reported with CS note and photos, no deck sketch is required or provided.						
Span 2: 107 - Steel Open Girder/Beam	TQ	CS-1	CS-2	CS-3	CS-4	CS-5
	347	0	345	2	0	0
	347	0	345	2	0	0
Condition State 3 Note Referenced Photo(s): 12 Referenced Sketch(es): 5						
G1 in Span 2 has 24% lower web section loss over the bearings and 13% overall shear area section loss at Pier 2 (Pic#12). G5 in Span 2 has 27% lower web section loss over the bearings and 16% overall shear area section loss at Pier

Original Beam		WF33 x 130	Bearing Length = 8.00						Tw = 0.580	d = 33.00				
By/Title	Date:	Location	Bearing Area						Overall Shear Area					
			A	B	C	Hole _L	Thk _{AB} _C	%S.L.	D	E	Hole _H	Thk _{SH}	%S.L.	
FMG/CU	4/16/2019	G1	0.48	0.398	0.455	0.00	0.443	24%	0.520	0.520	0.00	0.505	13%	
FMG/CU	4/16/2019	G5	0.47	0.435	0.370	0.00	0.423	27%	0.500	0.490	0.00	0.485	16%	
DC	4/22/2021	G5	0.47	0.440	0.365	0.00	0.424	27%	0.5	0.49	0.00	0.486	16%	
DC	4/22/2021	G1	0.48	0.395	0.460	0.00	0.444	23%	0.53	0.52	0.00	0.509	12%

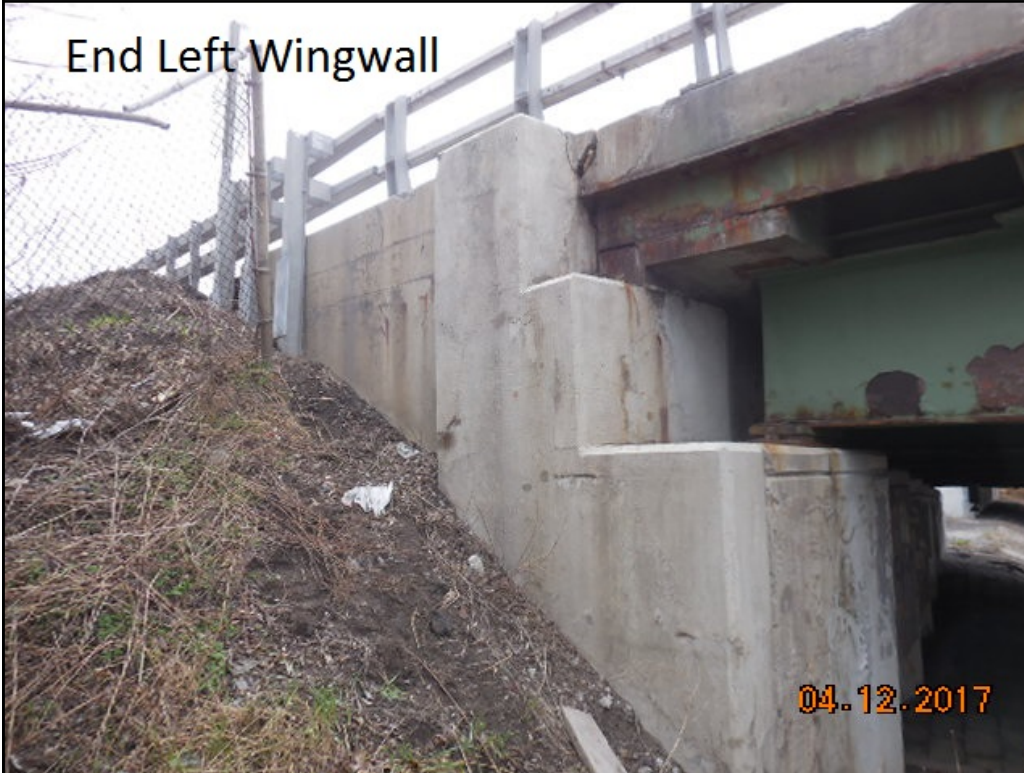
WingwallEndLeft_17.JPG

The End Left wingwall has a 1 foot long by 2 inch deep spall at the top corner near the abutment and an 8ft long x 5ft high section of map cracking with efflorescence and rust staining. See CS note for element EA853.
